2018 Aquatic and Riparian Restoration Annual Report

USDA Forest Service Pacific Northwest Region 2018 Aquatic and Riparian Restoration Annual Report

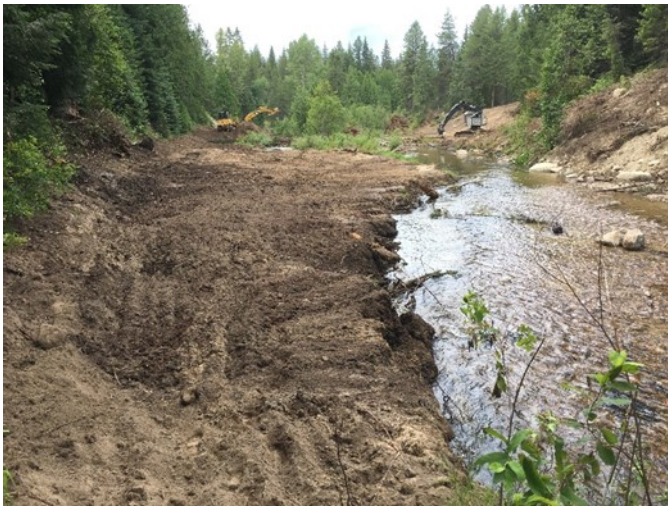
Restoring floodplain grade to historic elevation

Restoration included transporting and placing 650 trees with root wads attached, moving approximately 15,000 cubic yards of berms from the floodplain, re-establishing channel function in a 0.5 mile reach of stream adjacent to a historic (1920 era) Diamond Match Company mill site, blasting two log dams to restore fish passage to 18 miles of fish habitat, placing nearly 200 trees as LWD restoring natural stream hydrology, channel bed and bank dimensions, and upstream fish migration at those locations. The Lands Council and the Forest Service are collaborating with the large wood placement component of the project.

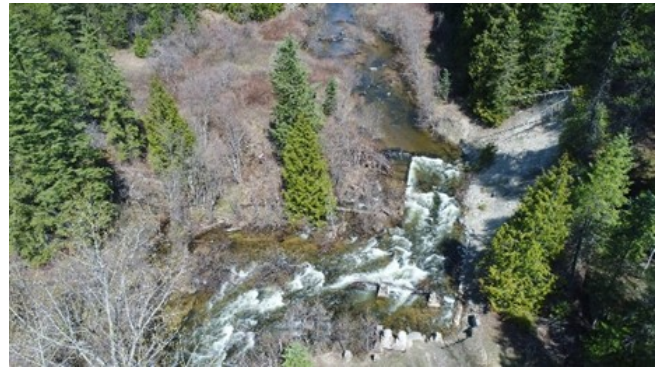
Pre-project drone image on West Branch

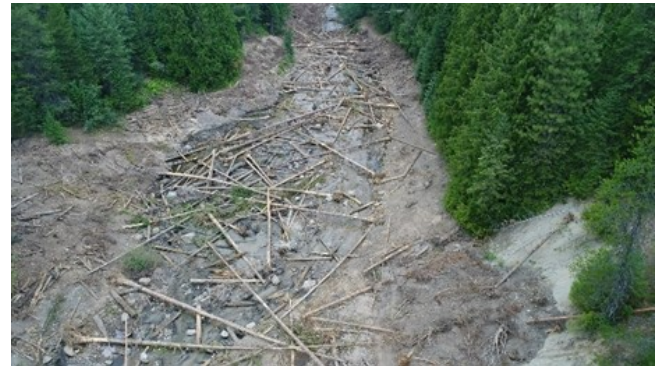
Post-project drone image on West Branch LeClerc

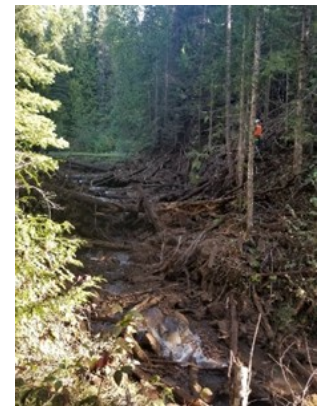
Log crib dam removal restoring passage to 18 miles upstream

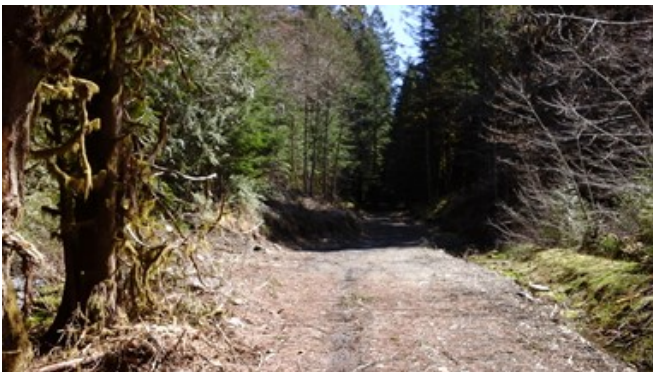
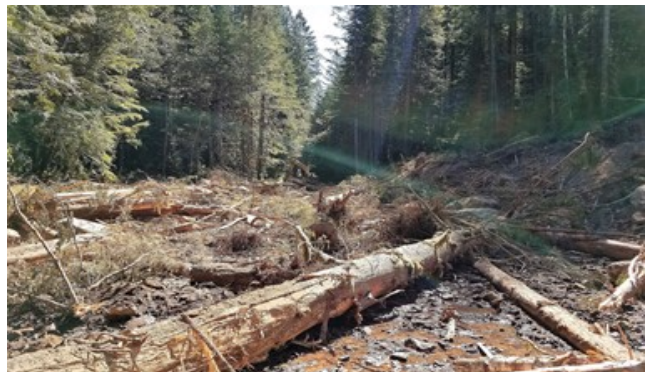
Photos showing floodplain reconnection and berm removal (Before and After).

The project included re-contouring the western most section of the road that “blew-out” over ten years ago, including removing a large earthen berm and de-compacting the remaining portion of the road. Five stream crossing structures, totaling six culverts, were removed. Additional cross-drain culverts were also removed. At three other locations, where relic stream channels cross the existing roadbed, road fill material was removed to allow stream channel and floodplain

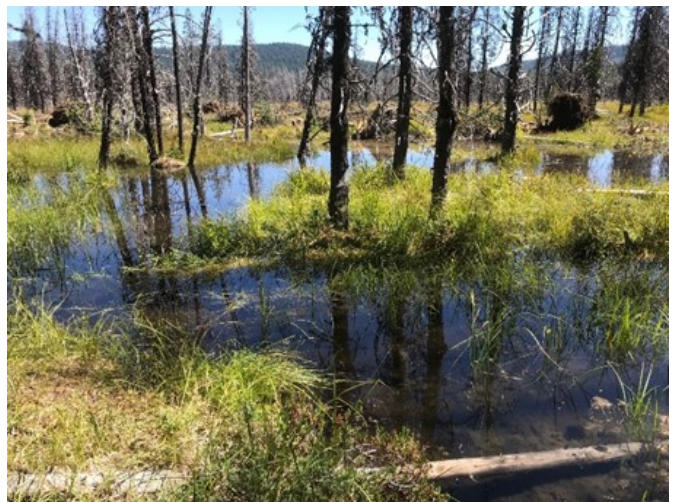
Relic wetlands rewetted following West Ditch obliteration.

This year's effort was focused at the upstream extents of the east and west ditches. Approximately 350 meters of ditch line on each side were filled with adjacent side cast berm material and lodgepole pine trees growing on the berm. Filling of these drainage ditches reduces the efficient discharge of flow from the marsh and increases the residence time for water. As a result, the shallow groundwater level is increased, rewetting the wetland.

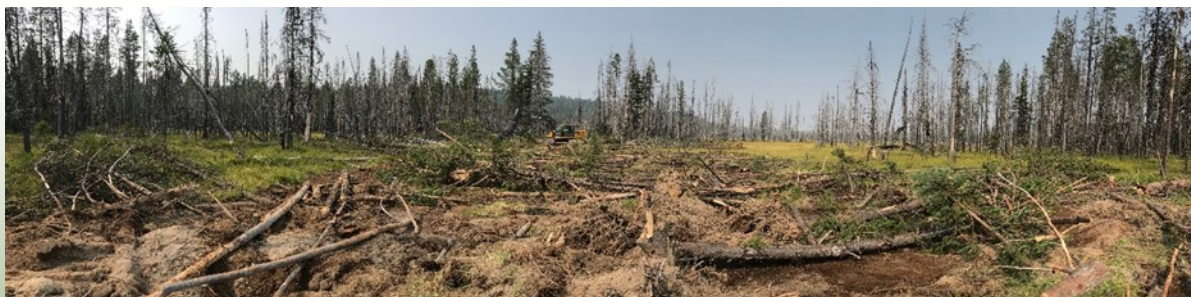
A segment of West Ditch was filled and pine trees spread over its surface, returning groundwater to the ground surface.

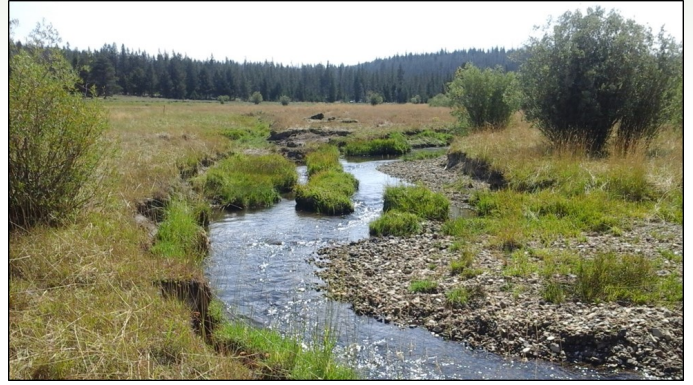
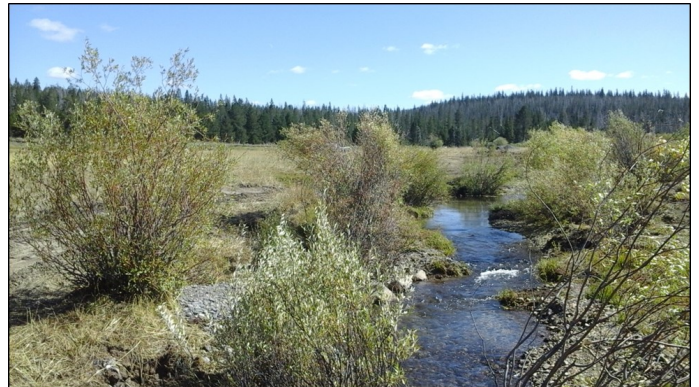
Upper Sycan Project before (above) and after (below) project implementation.

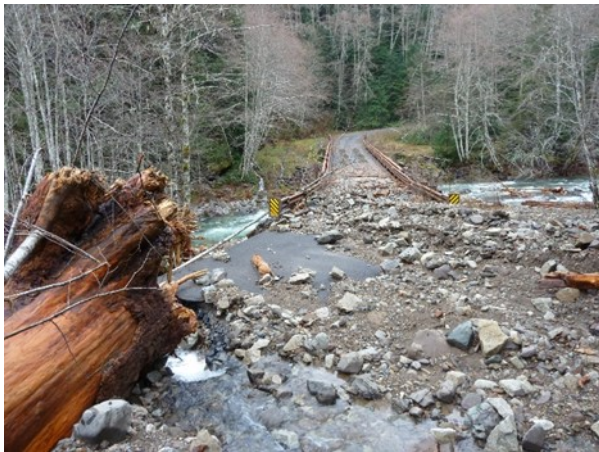
Example of large wood prevented from entering Yellowjacket Creek.

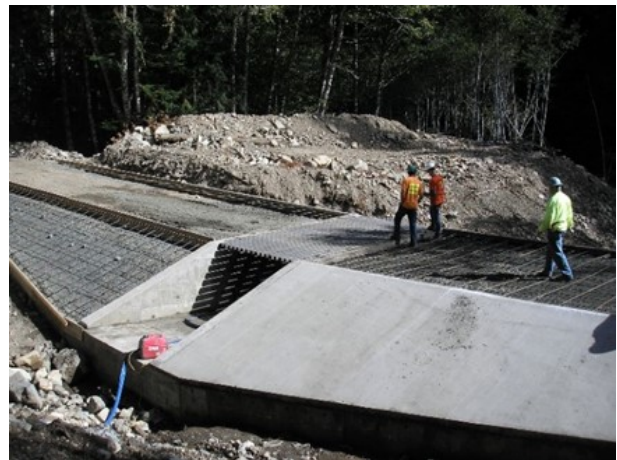
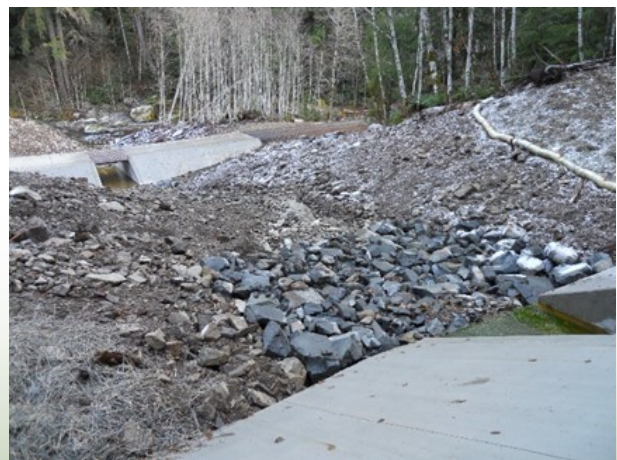
Above: Completed open box culverts with metal grates.

The project removed the damaged culverts and more than 1300 cubic yards of landslide material. Open box culverts (96" span 72" rise) with metal grates were constructed and a 200 foot stream course varying between 15-29% gradient established between the two roads. The open box culverts with paved slopes will allow more of the smaller sized sediment to move through the road crossing during bankfull events, and, during higher flows, allow more large wood material to transport over the structures into Yellowjacket Creek. The metal grate allows structure clearing of large sized deposited sediments, minimizing costs of future post storm repairs.

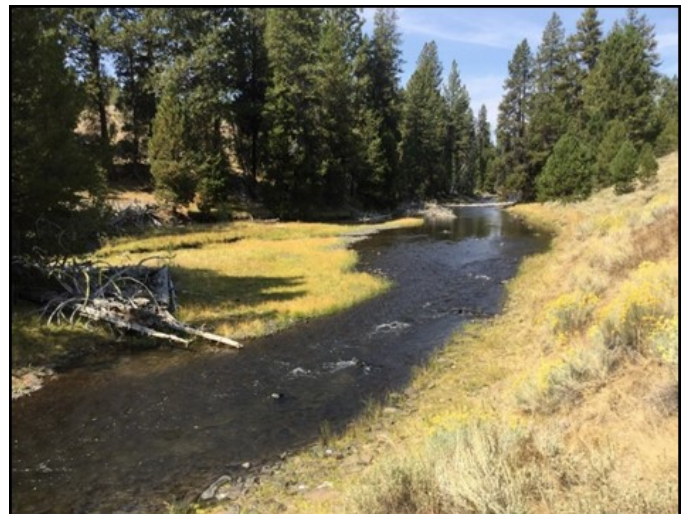
Before Restoration

Currently its aquatic habitat is considered to be in poor condition with the channel being too wide and simplified because of past management practices, including overgrazing, logging, and splash dams. At fewer than 2 pools per mile, the Malheur River is seriously lacking in this important habitat feature. Although this is not a National or Regional Priority Basin, its recovery is critical for the survival of the Malheur River Bull Trout.

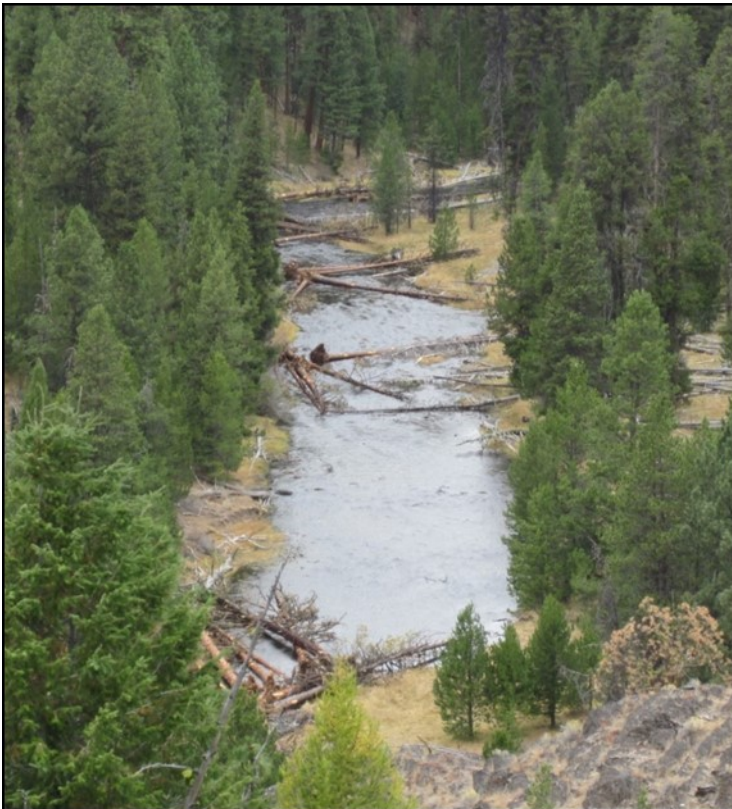
Above: Reach Overview of Malheur River after Restoration

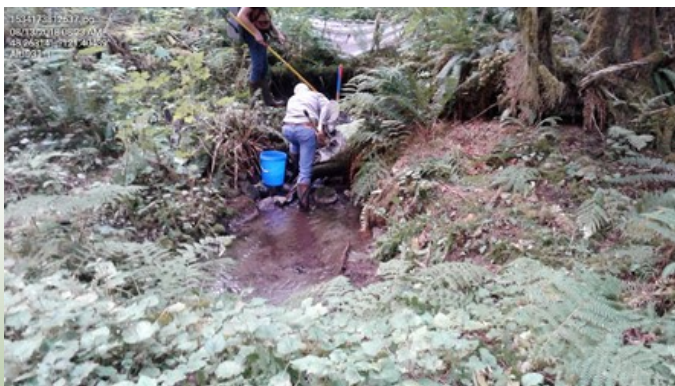
Tributary to Straight Creek at FSR 2500. Example of important off-channel habitat conditions.

The tributary to Straight Creek is low gradient both below and above the 2500 road crossing. The old undersized round culvert was replaced with a bottomless arch with the elements of the channel gradient, cross section, bed form, and particle distribution matched to what above and below streams conditions were.

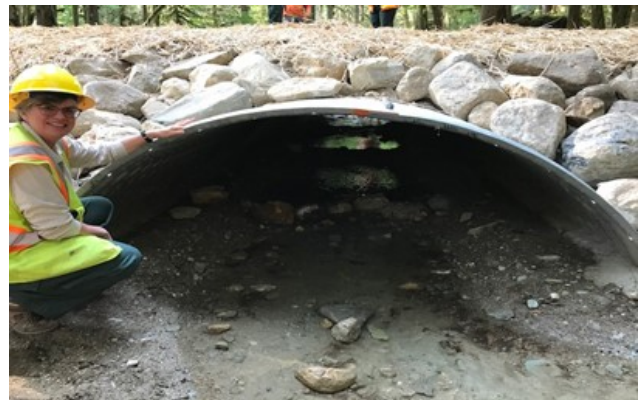
Tributary to Straight Creek at FSR 2500 at the bottomless arch culvert outlet.

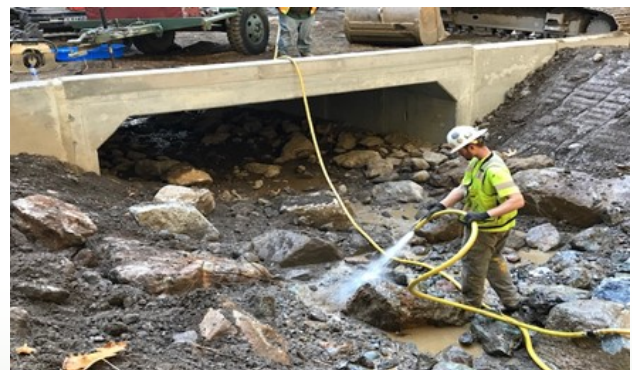
Tributary to Diobsud Creek at FSR 1050 at the box culvert inlet (during construction).

Construction at two sites, FSR 2800 (a bottomless arch) and 1050 (a box culvert), were completed in October 2018. Construction at the 2 sites on FSR 6300 (bottomless box culverts) will occur in July/August 2019. As with Straight Creek, the NF Stillaguamish tributary also is a low gradient stream that provides important off-channel habitat to Coastal Cutthroat Trout. The tributaries at Diobsud Creek and NF Skykomish River are slightly larger higher gradient step pool systems and provide spawning habitat for steelhead and Coastal Cutthroat Trout.

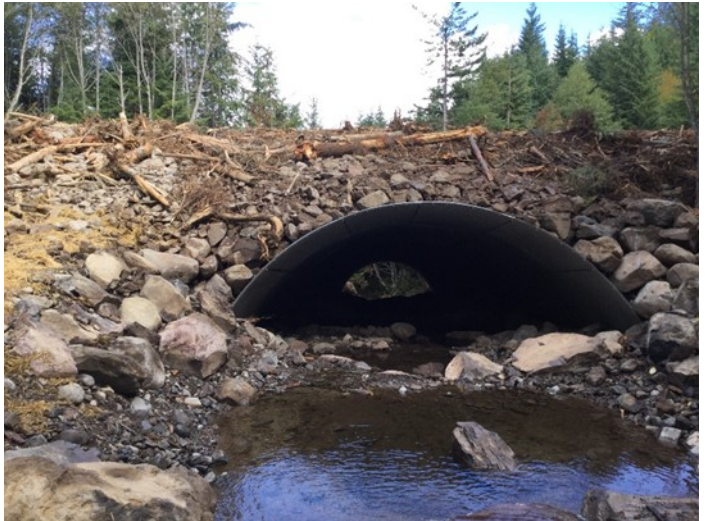
Post project: newly installed open bottom arch with stream simulation.

The road-stream crossing was replaced with an open arch structure able to withstand a 50 year flood event and reduce the risk of catastrophic failure. The project opened 4 miles of stream habitat, improved passage for all aquatic organisms, and will decrease downstream sedimentation.

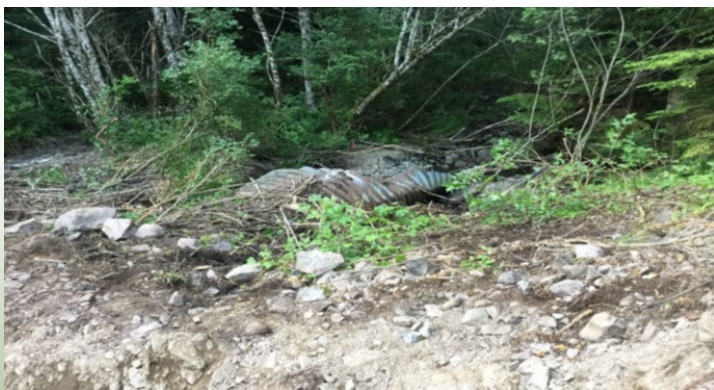
The existing culvert was undersized and did not meet design standards to accommodate normal annual flows within the watershed. The inlet was bent upwards, which resulted in large amounts of sediment and debris build up partially clogging the culvert. The outlet was perched eight feet above the stream bed which did not allow for native fish or other aquatic organism passage. Additionally the road bed, regularly used by the public, was cracking and showing signs of decomposition and failure.

Pre-project conditions

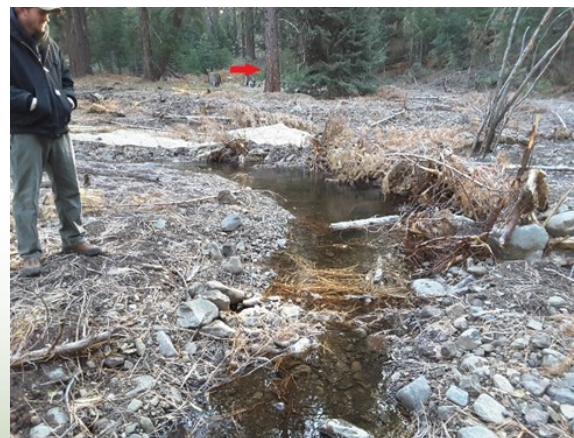
Post project view of channel reconnection to historic meandering channel.

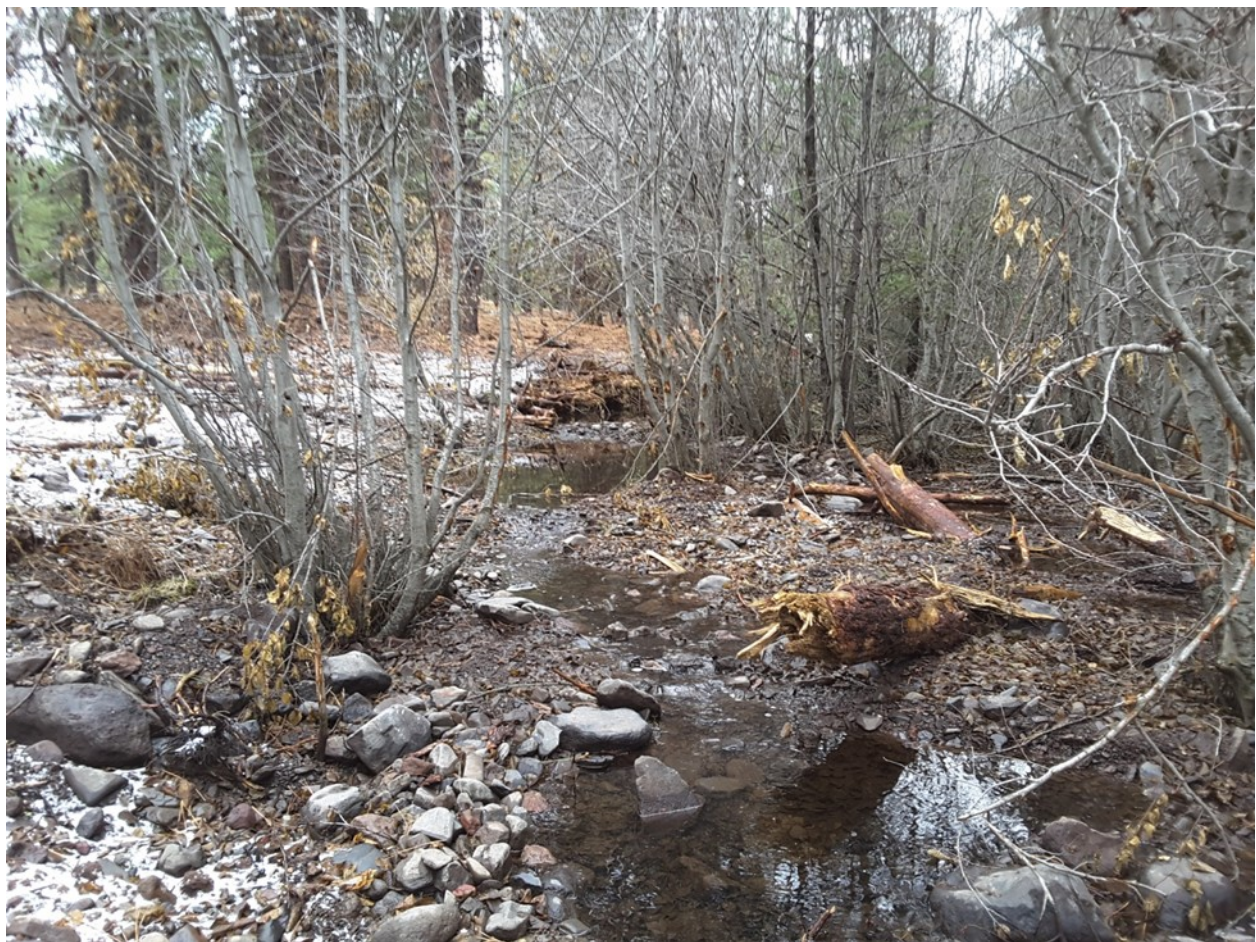
McKay Creek reconnected to historic floodplain surfaces after being raised six feet in this section.

Phase III of this project, implemented during the summer of 2018, applied a more actively constructed hybrid approach. This involved Priority 1 restoration techniques to raise groundwater levels and reset geomorphologic functioning, complemented by constructing immediate instream spawning and rearing habitat, and providing deep cold water summer refuge for fish. A single thread channel was designed, corresponding to past historic channel features observed using LIDAR mapping and reference reach data, and cleaned and sorted gravel was added to the channel. This channel focused on a defined low flow channel and underbuilt bankfull/floodplain surfaces to encourage flows to readily access a complex floodplain system. A series of constructed wetlands were located directly upstream of each of the lateral scour pools in the meander bends of the main channel to feed these pools with groundwater in order to provide summer refuge for fish.

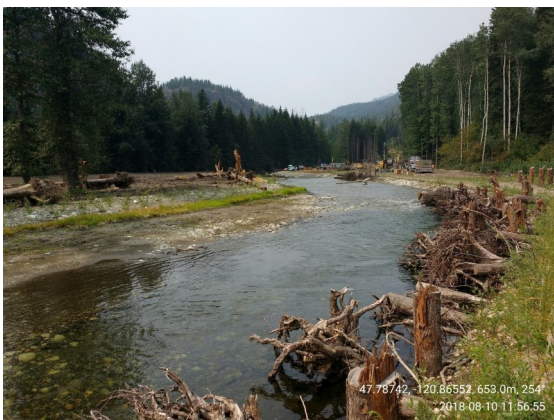
Phase 2 in 2017: using large wood structures to enhance habitat complexity.

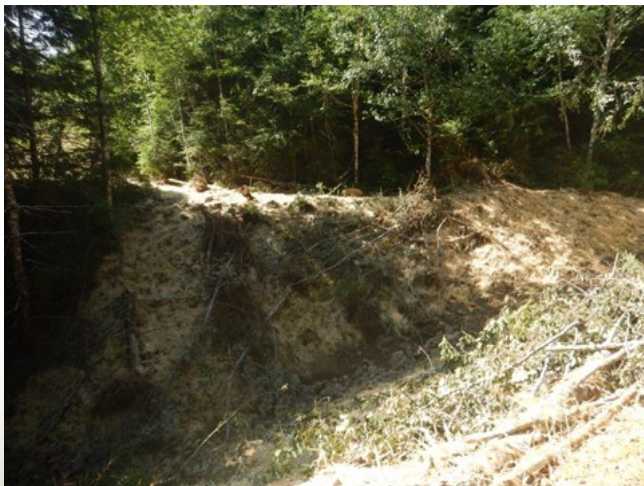
Pre-work: This road is in the Sitkum Priority Watershed and addressing its effects was part of a larger effort to improve the watershed condition as well as work towards achieving a sustainable road system.

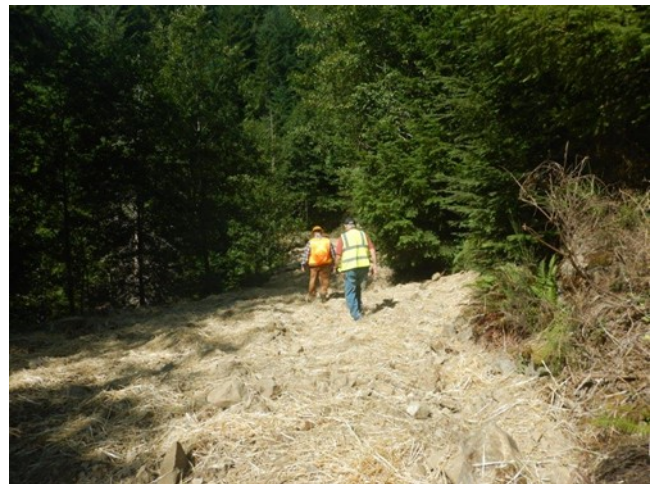
Completed Project: Road Decommissioned – the unstable road fill slope was pulled back to restore natural state

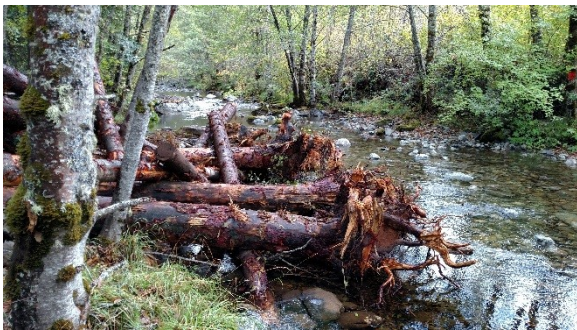
Dunn Creek log structure

The main objectives in 2016 and 2017 were to add large wood structures to the mainstem and side channels of Dunn Creek in order to dissipate energy during high flows, capture spawning gravel, and to provide cover during high and low flow conditions. Trees were obtained for the project from an unsold, second-growth timber sale unit that was not harvested due to economic reasons. The standing live trees are typically dug out and pushed over with an excavator, then cut into 35' sections to transport to the project area. Over 100 trees were marked and utilized for the project.

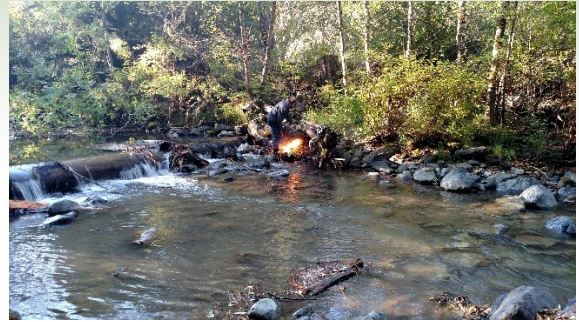
Deconstructing legacy habitat structures in Dunn Creek.

A secondary objective in 2017 was to remove legacy fish habitat structures that were perpetuating a degraded channel condition. Deconstruction included removing all cable and anchoring rebar from legacy structures and reconfiguring the wood to encourage a meandering thalweg. A combination of techniques were used to help the structures withstand the intensity of the Siskiyou flow regime – including using rock as ballast, interlacing structures into existing streamside vegetation, and keying logs into the streambank. More than 100 inches of annual precipitation and a “flashy” geology require that structures (and fish) can withstand intense flow events with regularity. Our structures were spatially placed within the channel to direct a portion of stream flow energy laterally instead of longitudinally. The structures will aid in capturing spawning gravels, which are lacking in the project reach, as well as provide summer and winter rearing habitat for salmonids.

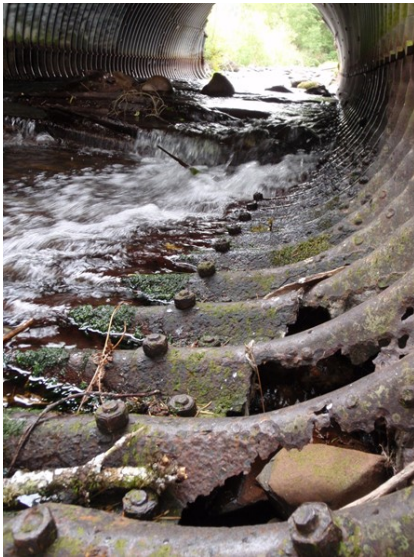
Before photo of Boulder Schrock crossing rusted culvert bottom.

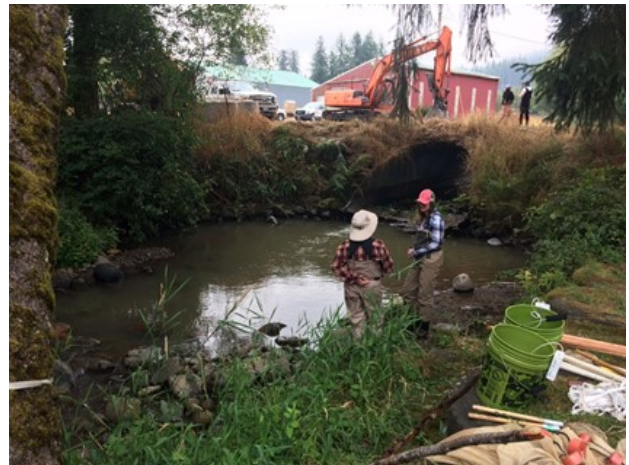
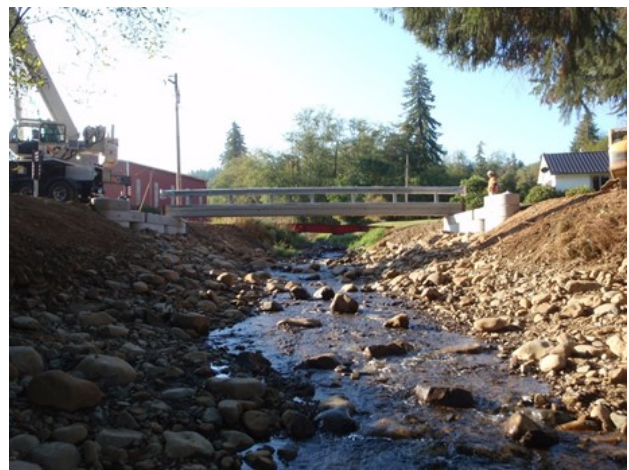
Before photo of Boulder Schrock crossing (top) and after photo (bottom) of bridge installed with stream simulation design.

This project replaced a nine-foot wide undersized culvert with a 40-foot wide concrete bridge across Boulder Creek. Implementing this project improves fish passage to over four miles of habitat for threatened Coho Salmon, Chinook, steelhead, Cutthroat Trout, and Pacific Lamprey. It will improve natural sediment and nutrient transport, and mitigate the risk of culvert failure in the event of large storms. By increasing critical spawning and rearing habitat availability in the Boulder Creek watershed, salmonid populations will be more resilient to future impacts from stochastic events, climate change, or management impacts. In addition, this project is an important piece of the Salmon SuperHighway fish passage partnership, which has a goal of improving fish

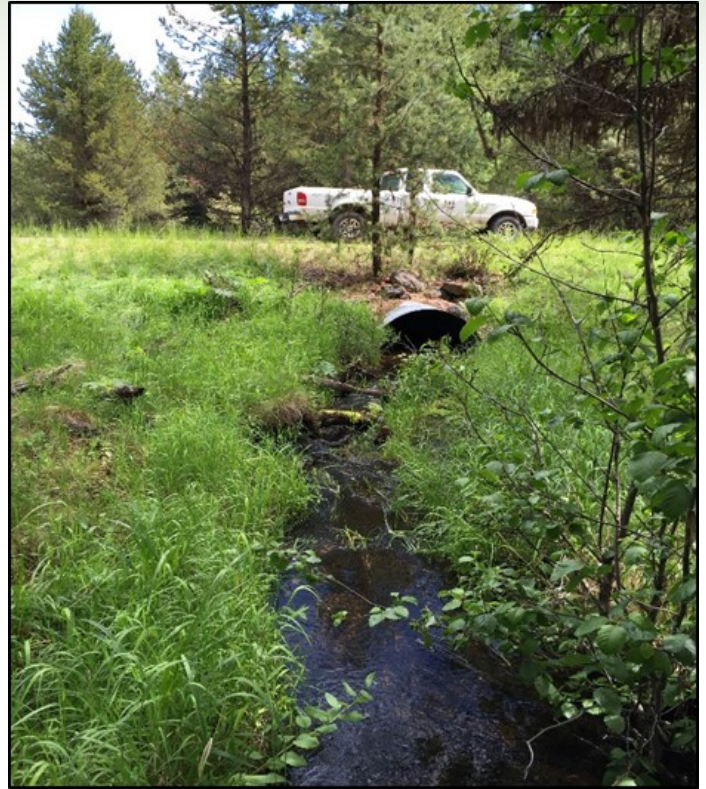
The undersized culvert at West Chicken Creek road crossing prior to project implementation.

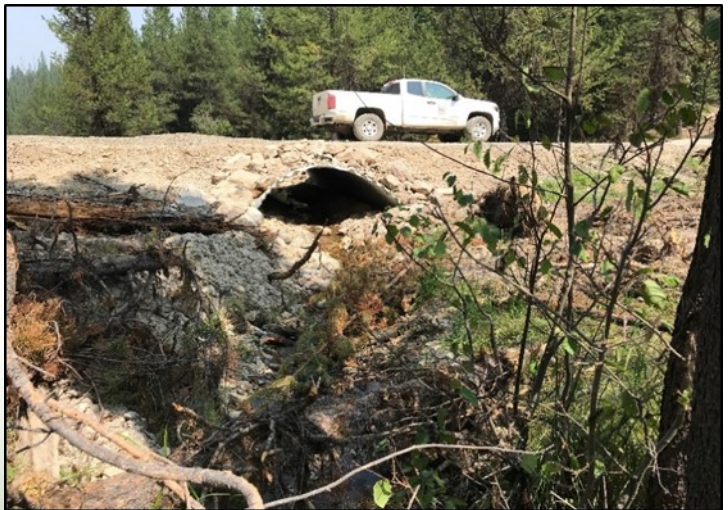
The undersized round culvert was replaced with this bottomless arch sized to accommodate estimated peak flows.

In 2018, the Forest Service implemented an AOP project upgrading a culvert on Forest Service Road 5175, where it crosses West Chicken Creek. The total cost for the project was \$61,653 which was funded by Legacy Roads funding. The existing culvert was a standard round 24 inch pipe and was replaced with a bottomless arch with a natural streambed surface. With the implementation of this project, the Chicken Creek subwatershed will be reported as “improved” in 2019 under the Watershed Condition Framework.

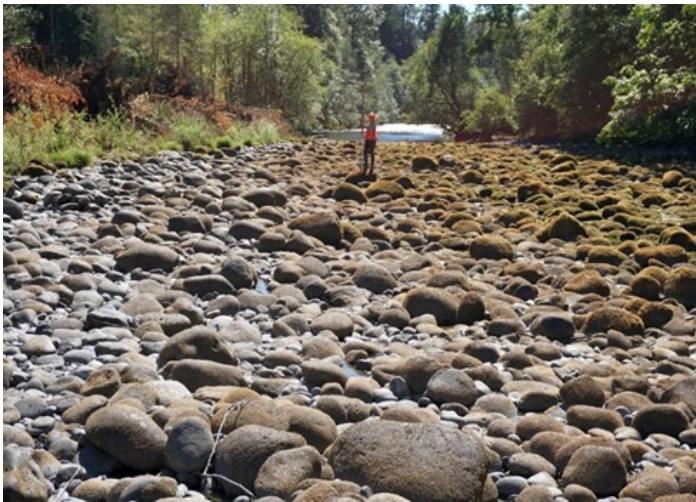
The temporarily dewatered South Fork channel revealed substrate much too large for spawning.

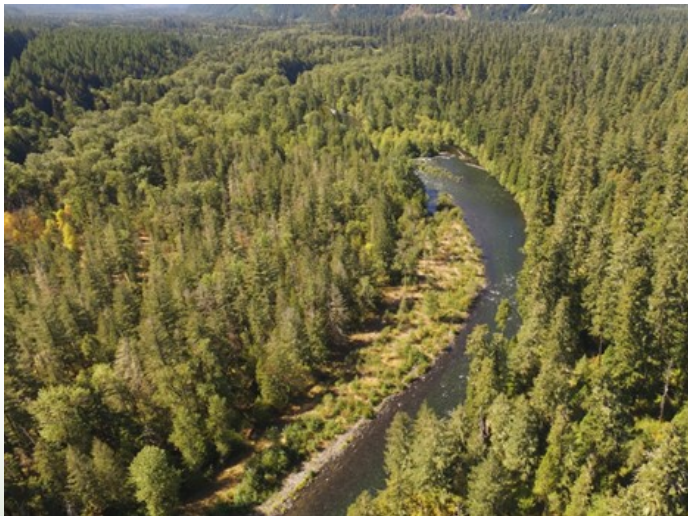
Pre-project aerial image of lower South Fork as an incised, primarily single-thread channel.

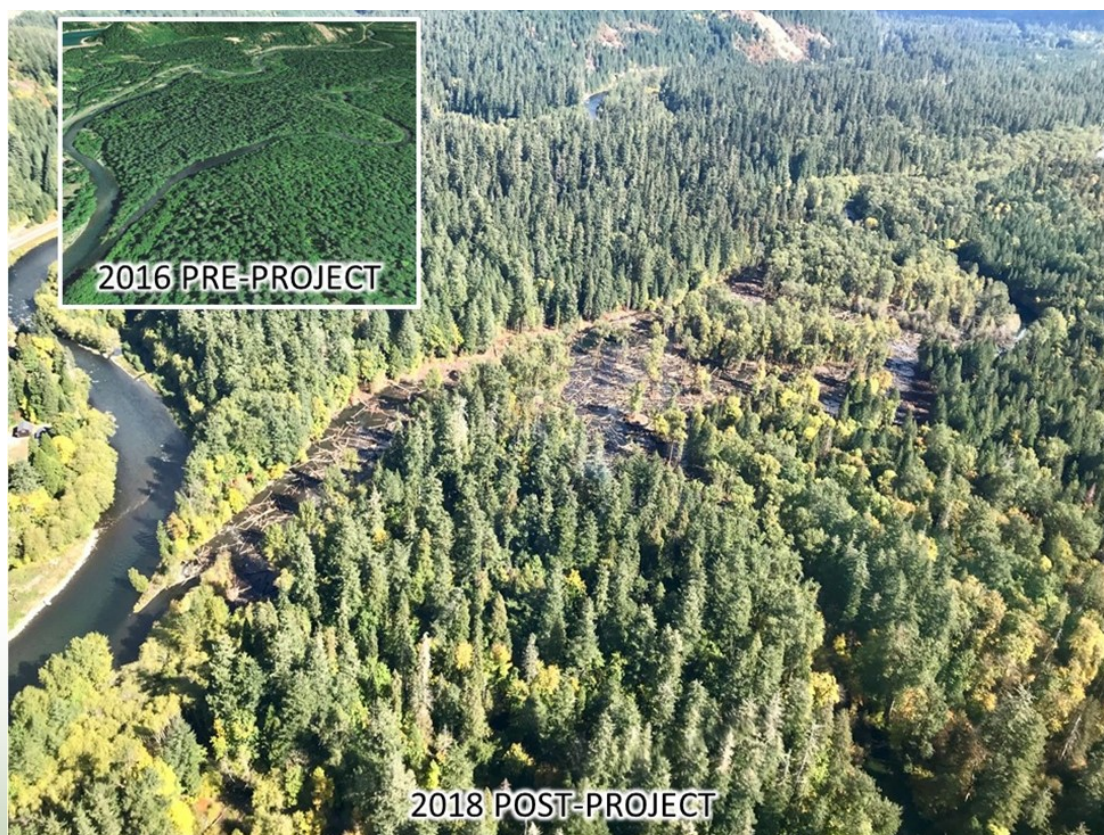
Pre- and post-project aerial images of the Phase I Project Area. Note the dramatic expansion of base flow wetted area and increase in large woody material.

the valley bottom and improved habitat in 5 miles of the river. The project increased large wood frequency in channels and across the floodplain from less than 3 to over 23 pieces per acre. About 90,000 cubic yards of sediment from onsite were redistributed into the incised mainstem channel, followed by the placement of over 3,000 pieces of large wood across the valley bottom. Ecological function and habitat condition has already been vastly improved. Immediately following implementation, the base flow wetted area increased from 8 acres to over 30 acres of complex, high quality aquatic habitat. Within two months following implementation, 14 spring Chinook salmon redds were documented in the Phase I project area, where no redds had been seen before.
